# Coastal Landslide Hazards

# Bartlett Island Quadrangle, Maine

## Maine Geological Survey

Open-File No. 03-9  
2003

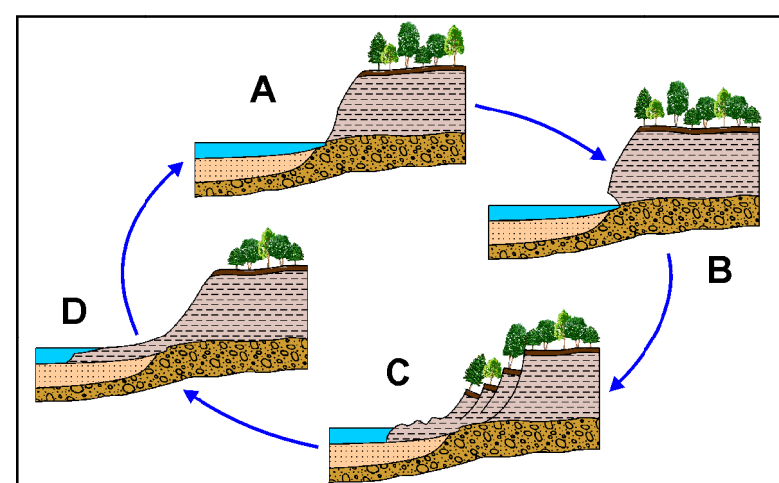
Figure 2. Life cycle of a landslide on a bluff composed of sediment (modified from Kelley and others, 1989).

Sea level is gradually rising along the coast of Maine (Kelley and others, 1996). This rise in the ocean allows waves to erode beaches and flats at the base of coastal bluffs (see Figure 2A). Over time, erosion removes material from the base of a coastal bluff and steepens the face of the bluff (Figure 2B). Sediments at the base of the bluff stabilize it, and when they are removed, the bluff is no longer in equilibrium. Only the strength of the material within the bluff holds the bluff in place. Continued erosion or lubrication of the bluff materials by ground water may overcome this internal resistance, particularly in clay bluffs, and result in a landslide (Figure 2C). A landslide restores the equilibrium of the bluff, and the slumped materials support a new bluff face with a gentler profile (Figure 2D). Erosion, however, is a continuing process because the level of the sea is rising, and coastal waves and currents immediately begin to remove the edges of the displaced sediment. Eventually, erosion destroys the equilibrium of the bluff and leads to another landslide, repeating the cycle shown at right.

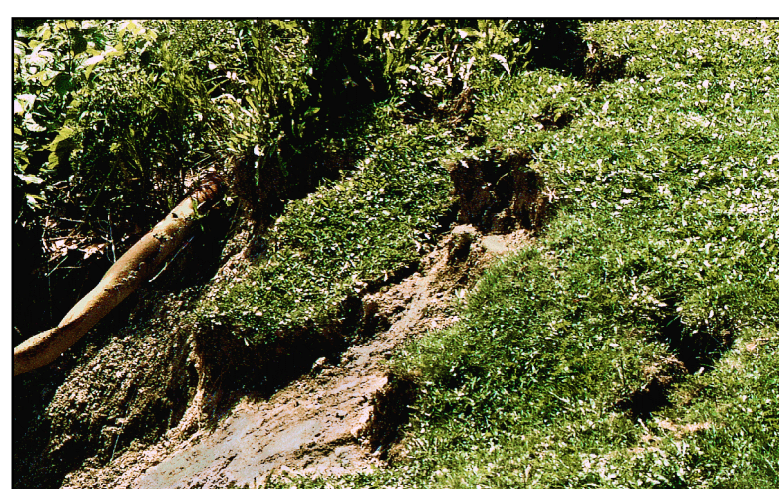
Figure 4. Downslope forces within a bluff cause surface layers to stretch. When the tension becomes great enough, a crack forms and the pressure is released. These "tension cracks" may form on the top edge of the bluff or on the bluff slope itself. They indicate instability and motion within the bluff. Some cracks are deep and extend below the soil layer.
