Coastal Landslide Hazards

Cape Rosier Quadrangle, Maine

Open-File No. 03-15

2003

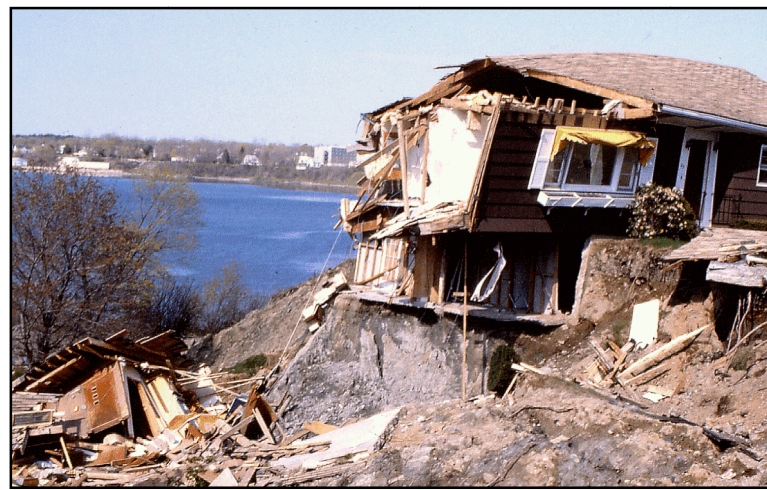
Figure 1. A clay bluff on the north shore of Rockland Harbor failed in 1996. This landslide formed a new scarp about 200 feet landward of the original top of the bluff in just a few hours. Two homes were destroyed as a result of this catastrophic slide (see Berry and others, 1996).

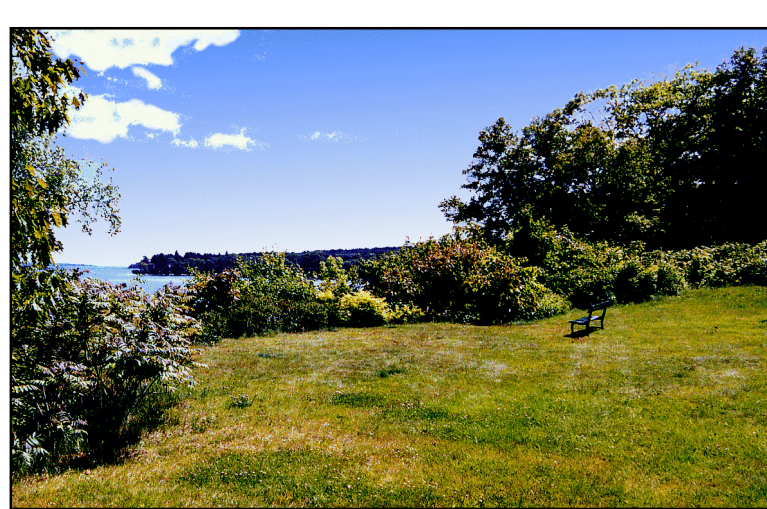
Figure 3. The shape of the top edge of a bluff can be an indicator of landslide risk. Clay bluffs often fail at points of weakness. Such a "slump" can expand into a larger landslide that cuts into the bluff and forms a curve around the original point of failure. Multiple slides and slumps will form an irregular or arcuate top edge to the bluff as shown in the photo above. Bluffs made of coarse materials or sand have a more even upper edge caused by a more constant rate of erosion along the bluff face.

Careful observation of the land surface, vegetation, and shape of a coastal bluff reveals evidence of instability. Starting at the top of a bluff, an irregular or arcuate edge can indicate past landslides or areas of increased coastal erosion (Figure 3). When a weak point on a bluff fails, the slide moves inward into the slope face forming a curve around the original point of failure. Tension cracks may form near a weak zone where the soil surface is moving downslope (Figure 4). These cracks appear as splits in the ground where the soil and vegetation have moved apart. Cracks may be visible along the top edge of the bluff or on the bluff face itself. On the slope of a bluff, a hummocky land surface or terraces indicate past slumping or landslides (Figure 5). Unvegetated slump scars or slopes are obvious evidence of rapid soil movement. A bowl-shaped slope often shows the location of a former landslide, with the center of the bowl as the area of greatest failure. Distorted vegetation provides evidence of soil creep or former landslides. Tree trunks curved near their base are evidence of downslope movement (Figure 6). Trees tilted at different angles are evidence of former slides or undercutting by erosion. At the base of a bluff, toppled trees and bare roots are evidence of erosion that steepens the bluff (Figure 7). Undercutting and steepening of the bluff may destabilize the slope and lead to increased erosion and possibly a landslide. Lobes or terraces of sediment in the intertidal zone are often remnants of old landslides. Although the evidence of earth movement listed above cannot predict a landslide, it is used to recognize unstable shorelines. This landform evidence is related to factors listed below that influence landslide risk.

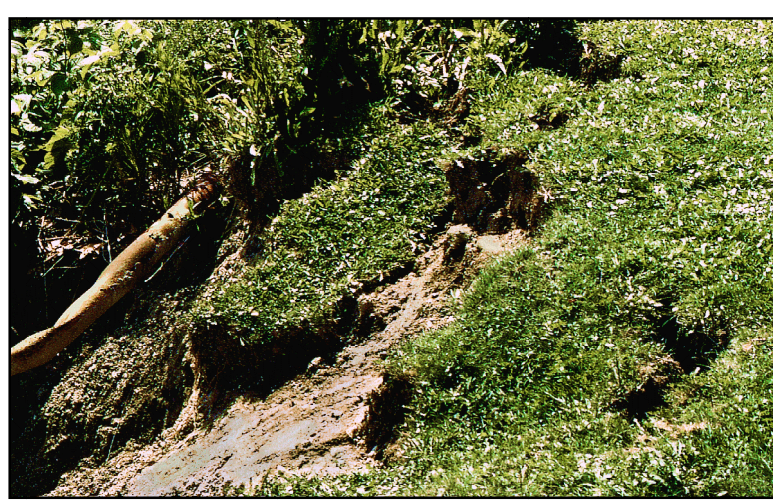
Figure 4. Downslope forces within a bluff cause surface layers to stretch. When the tension becomes great enough, a crack forms and the pressure is released. These "tension cracks" may form on the top edge of the bluff or on the bluff slope itself. They indicate instability and motion within the bluff. Some cracks are deep and extend below the soil layer.
