Coastal Landslide Hazards

Swans Island Quadrangle, Maine

Maine Geological Survey

Open-File No. 03-17
2003

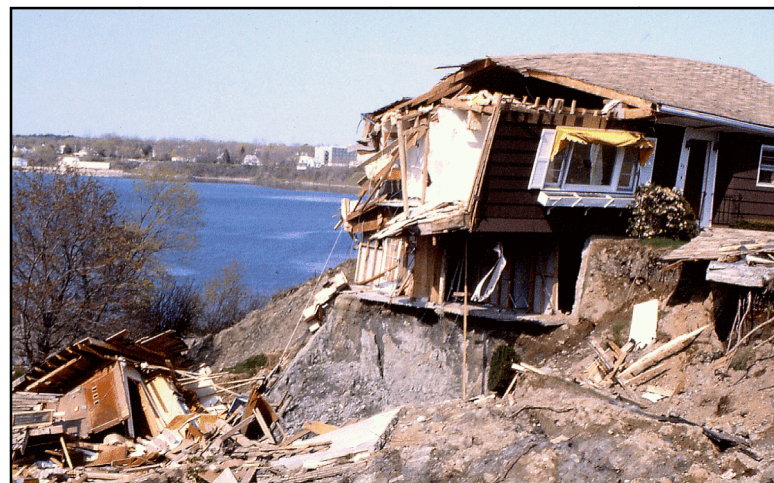
Figure 1. A clay bluff on the north shore of Rockland Harbor failed in 1996. This landslide formed a new scarp about 200 feet landward of the original top of the bluff in just a few hours. Two homes were destroyed as a result of this catastrophic slide (see Berry and others, 1996).

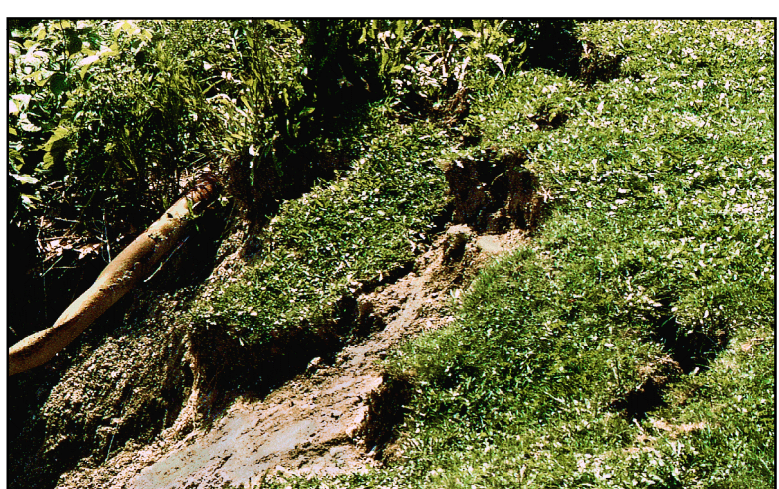
Figure 4. Downslope forces within a bluff cause surface layers to stretch. When the tension becomes great enough, a crack forms and the pressure is released. These "tension cracks" may form on the top edge of the bluff or on the bluff slope itself. They indicate instability and motion within the bluff. Some cracks are deep and extend below the soil layer.

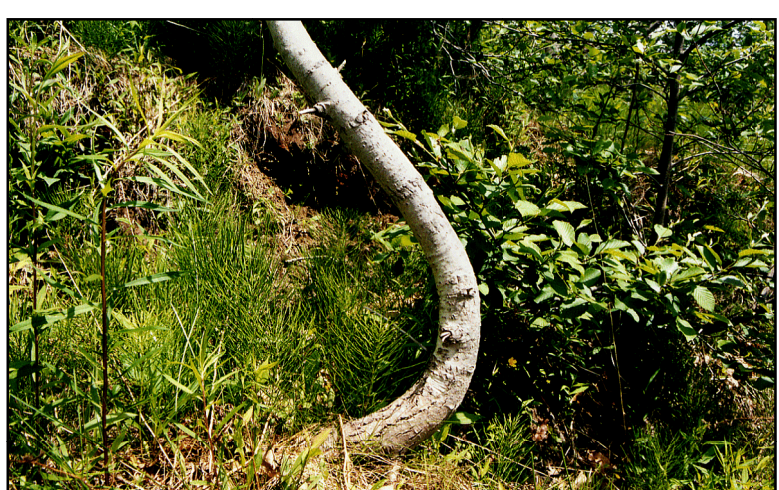
Figure 5. Wave erosion at the base of a bluff removes slope sediment and steepens the bluff. Erosion has undercut the trees in the photo above and caused them to tilt toward the ocean. This steepening reduces the stability of the bluff, and a landslide may result. Ongoing sea-level rise along the Maine coast will cause wave erosion at the base of coastal bluffs and continue to make some coastal bluffs at risk of experiencing a landslide.
