Coastal Landslide Hazards

North Haven West Quadrangle, Maine

Open-File No. 03-19
2003

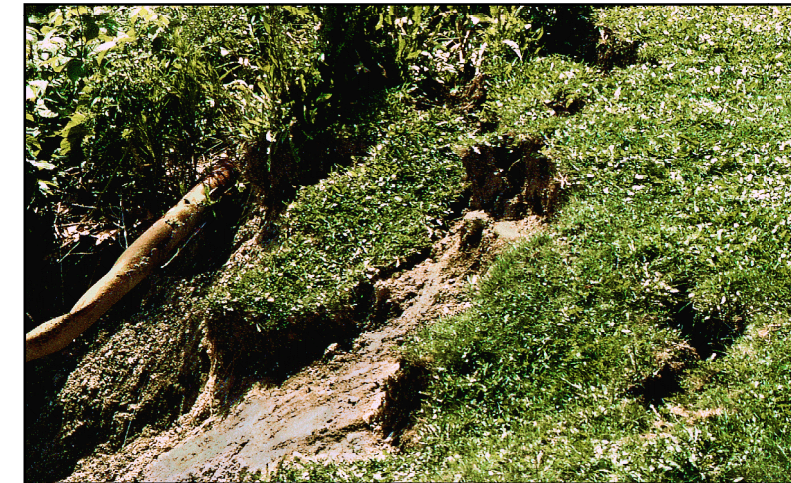
Figure 4. Downslope forces within a bluff cause surface layers to stretch. When the tension becomes great enough, a crack forms and the pressure is released. These "tension cracks" may form on the top edge of the bluff or on the bluff slope itself. They indicate instability and motion within the bluff. Some cracks are deep and extend below the soil layer.

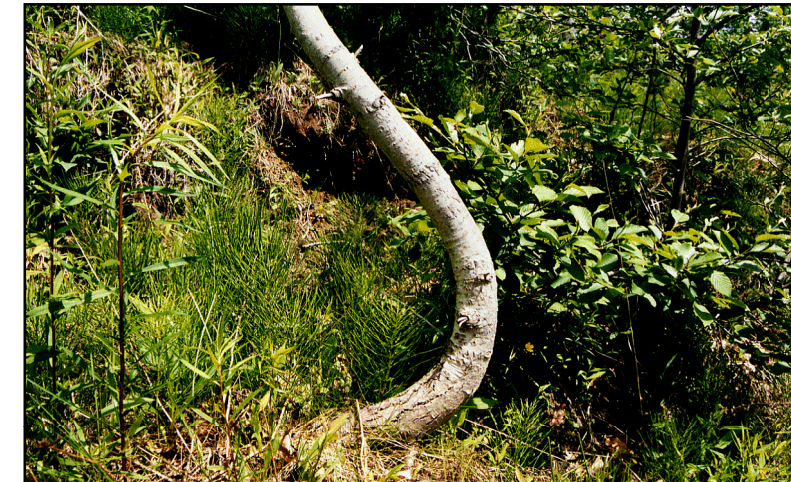
Figure 5. Soil "creep," or downslope movement of soil on a slope, will cause tree trunks to tilt toward the base of the slope. As a moving tree continues to grow, the trunk will curve as the tree tries to right itself over ground toward the sun. Landslides will also cause tree trunks to become curved.

Vegetation. Types, shapes, and distribution of vegetation above and on a bluff face can be used as an indication of site stability. In areas where the soil has shifted, either due to previous landslides or to gradual surface creep, many tree trunks can become tilted or twisted in the same direction. Curved tree trunks near the roots often indicate land movement down the face of a bluff. Large trees on the bluff face may be moved by wind and resulting root motion may loosen bluff sediment. Natural vegetation that consists only of small shrubs and trees may indicate recent bluff erosion or a landslide.

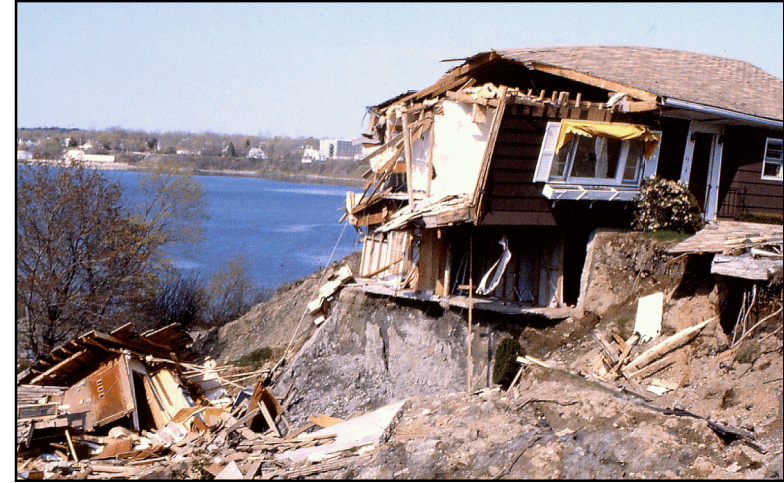
Figure 1. A clay bluff on the north shore of Rockland Harbor failed in 1996. This landslide formed a new scarp about 200 feet landward of the original top of the bluff in just a few hours. Two homes were destroyed as a result of this catastrophic slide (see Berry and others, 1996).

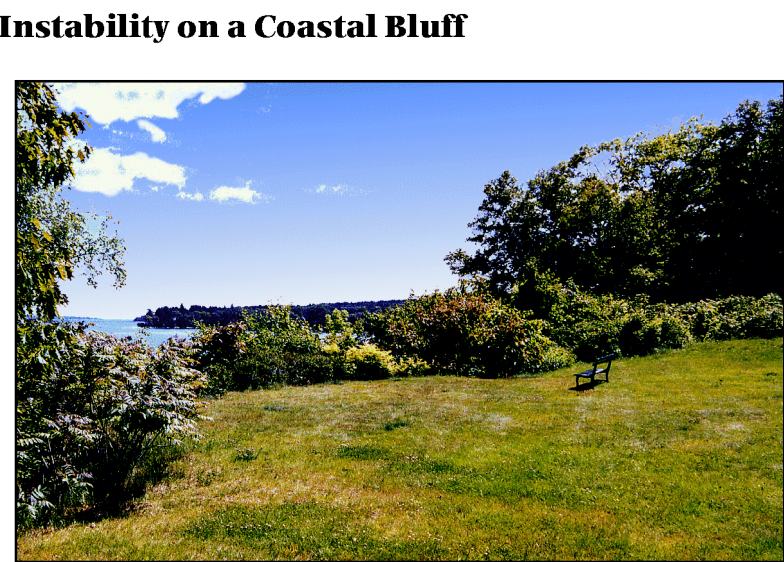
Figure 3. The shape of the top edge of a bluff can be an indicator of landslide risk. Clay bluffs often fail at points of weakness. Such a "slump" can expand into a larger landslide that cuts into the bluff and forms a curve around the original point of failure. Multiple slides and slumps will form an irregular or arcuate top edge to the bluff as shown in the photo above. Bluffs made of coarse materials or sand have a more even upper edge caused by a more constant rate of erosion along the bluff face.

Careful observation of the land surface, vegetation, and shape of a coastal bluff reveals evidence of instability. Starting at the top of a bluff, an irregular or arcuate edge can indicate past landslides or areas of increased coastal erosion (Figure 3). When a weak point on a bluff fails, the slide moves inward into the slope face forming a curve around the original point of failure. Tension cracks may form near a weak zone where the soil surface is moving downslope (Figure 4). These cracks appear as splits in the ground where the soil and vegetation have moved apart. Cracks may be visible along the top edge of the bluff or on the bluff face itself. On the slope of a bluff, a hummocky land surface or terraces indicate past slumping or landslides (Figure 5). Unvegetated slump scars or slopes are obvious evidence of rapid soil movement. A bowl-shaped slope often shows the location of a former landslide, with the center of the bowl as the area of greatest failure. Distorted vegetation provides evidence of soil creep or former landslides. Tree trunks curved near their base are evidence of downslope movement (Figure 6). Trees tilted at different angles are evidence of former slides or undercutting by erosion. At the base of a bluff, toppled trees and bare roots are evidence of erosion that steepens the bluff (Figure 7). Undercutting and steepening of the bluff may destabilize the slope and lead to increased erosion and possibly a landslide. Lobes or terraces of sediment in the intertidal zone are often remnants of old landslides. Although the evidence of earth movement listed above cannot predict a landslide, it is used to recognize unstable shorelines. This landform evidence is related to factors listed below that influence landslide risk.

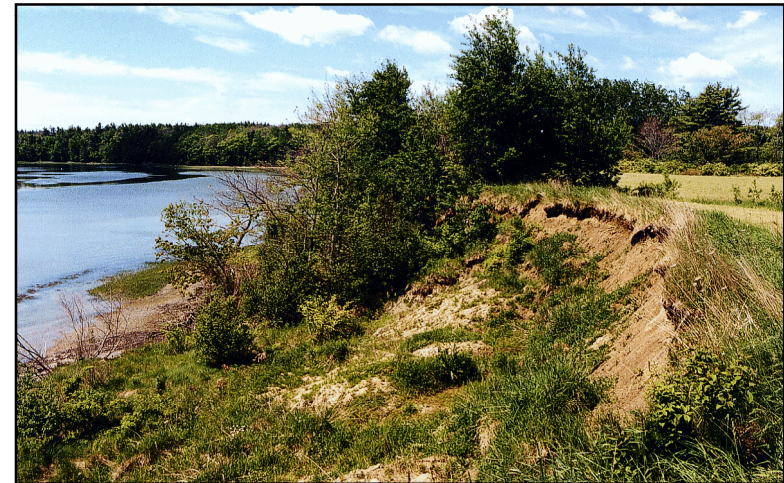
Figure 5. Wave erosion at the base of a bluff removes slope sediment and steepens the bluff. Erosion has undercut the trees in the photo above and caused them to tilt toward the ocean. This steepening reduces the stability of the bluff, and a landslide may result. Ongoing sea-level rise along the Maine coast will cause wave erosion at the base of coastal bluffs and continue to make some coastal bluffs at risk of experiencing a landslide.

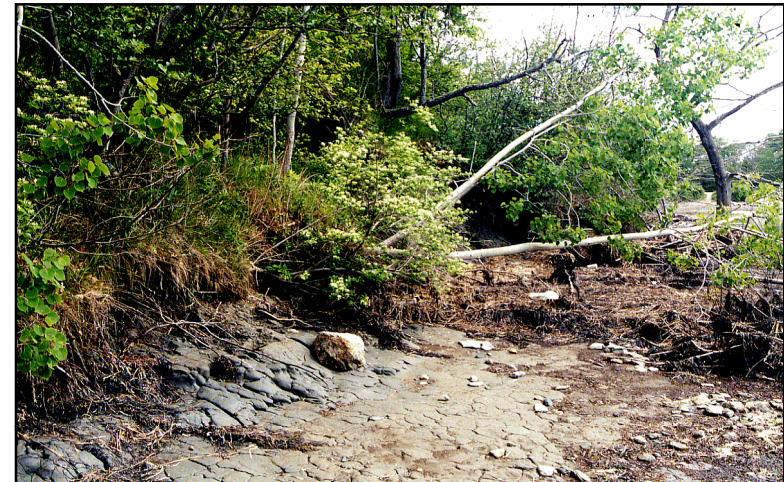
Figure 7. Wave erosion at the base of a bluff removes slope sediment and steepens the bluff. Erosion has undercut the trees in the photo above and caused them to tilt toward the ocean. This steepening reduces the stability of the bluff, and a landslide may result. Ongoing sea-level rise along the Maine coast will cause wave erosion at the base of coastal bluffs and continue to make some coastal bluffs at risk of experiencing a landslide.
