# Coastal Landslide Hazards

# Searsport Quadrangle, Maine

## Open-File No. 03-23

2003

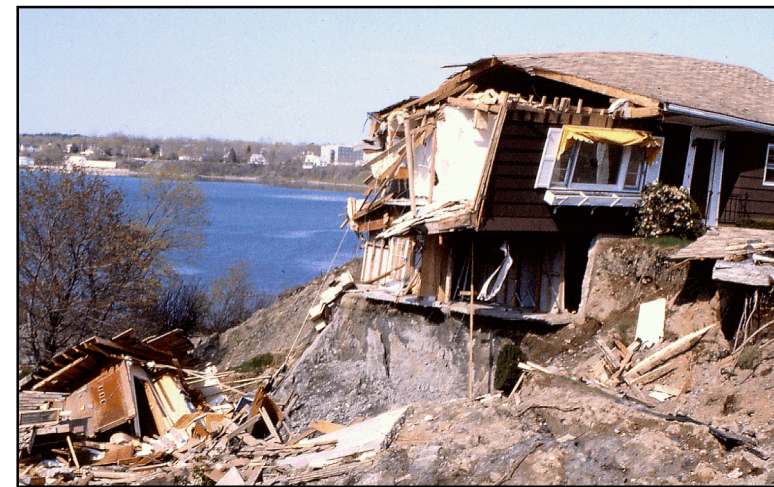
Figure 1. A clay bluff on the north shore of Rockland Harbor failed in 1996. This landslide formed a new scarp about 200 feet landward of the original top of the bluff in just a few hours. Two homes were destroyed as a result of this catastrophic slide (see Berry and others, 1996).

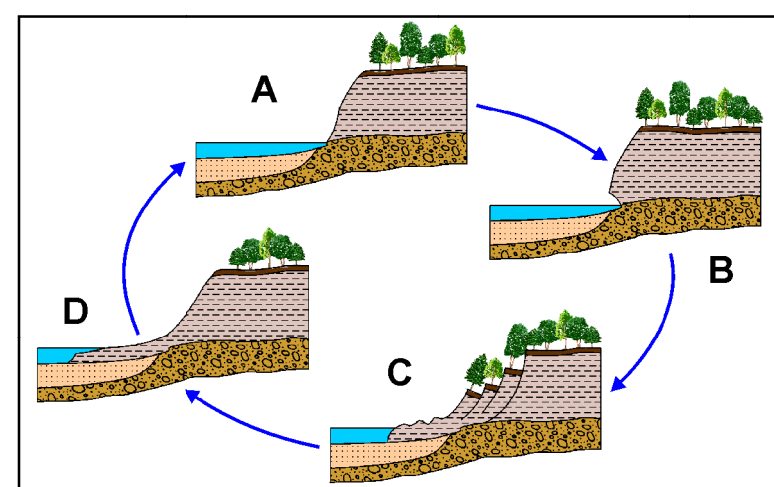
Figure 2. Life cycle of a landslide on a bluff composed of sediment (modified from Kelley and others, 1989).

Sea level is gradually rising along the coast of Maine (Kelley and others, 1996). This rise in the ocean allows waves to erode beaches and flats at the base of coastal bluffs (see Figure 2A). Over time, erosion removes material from the base of a coastal bluff and steepens the face of the bluff (Figure 2B). Sediments at the base of the bluff stabilize it, and when they are removed, the bluff is no longer in equilibrium. Only the strength of the material within the bluff holds the bluff in place. Continued erosion or lubrication of the bluff materials by ground water may overcome this internal resistance, particularly in clay bluffs, and result in a landslide (Figure 2C). A landslide restores the equilibrium of the bluff and the slumped materials at the foot of the bluff support a new bluff face with a gentler profile (Figure 2D). Erosion, however, is a continuing process because the level of the sea is rising, and coastal waves and currents immediately begin to remove the edges of the displaced sediment. Eventually, erosion destroys the equilibrium of the bluff and leads to another landslide, repeating the cycle shown at right.

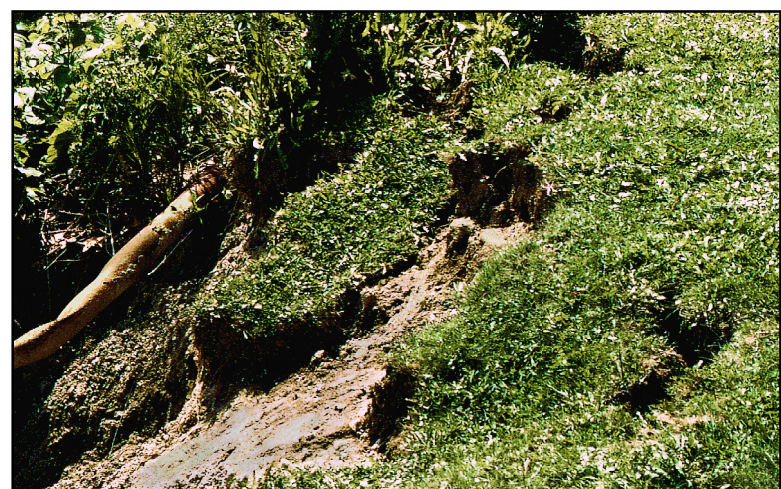
Figure 4. Downslope forces within a bluff cause surface layers to stretch. When the tension becomes great enough, a crack forms and the pressure is released. These "tension cracks" may form on the top edge of the bluff or on the bluff slope itself. They indicate instability and motion within the bluff. Some cracks are deep and extend below the soil layer.

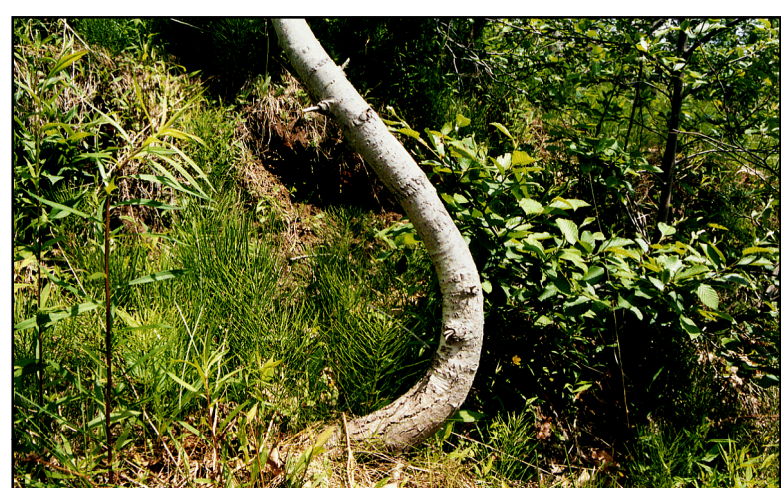
Figure 6. Soil "creep" or downslope movement of soil on a slope, will cause tree trunks to tilt toward the base of the slope. As a moving tree continues to grow, the trunk will curve as the tree tries to right itself and grow toward the sun. Landslides will also cause tree trunks to become curved.

**Vegetation** - Types, shapes, and distribution of vegetation above and on a bluff face can be used as an indication of site stability. In areas where the soil has shifted, either due to previous landslides or to gradual surface erosion, many tree trunks can be overtilted or twisted in the same direction. Curved tree trunks near the roots often indicate land movement down the face of a bluff. Large trees on the bluff face may be moved by wind and resulting root motion may loosen bluff sediment. Natural vegetation that consists only of small shrubs and trees may indicate recent bluff erosion or a landslide.

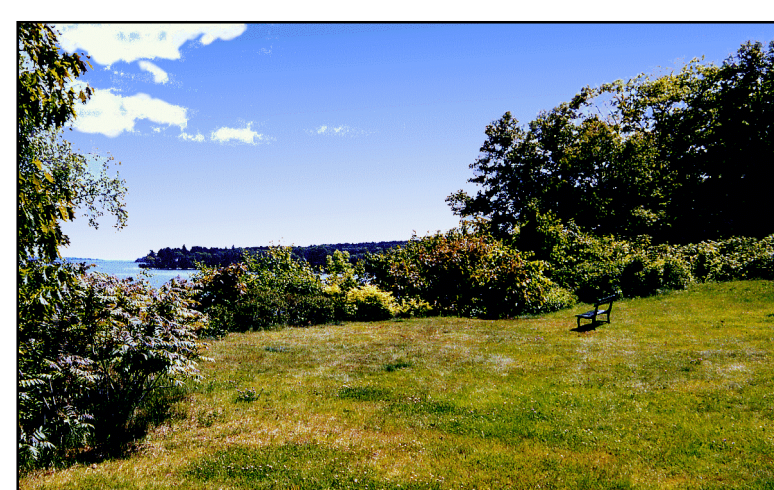
Figure 3. The shape of the top edge of a bluff can be an indicator of landslide risk. Clay bluffs often fail at points of weakness. Such a "slump" can expand into a larger landslide that cuts into the bluff and forms a curve around the original point of failure. Multiple slides and slumps will form an irregular or arcuate top edge of the bluff as shown in the photo above. Bluffs made of coarse materials or sand have a more even upper edge caused by a more constant rate of erosion along the bluff face.

Careful observation of the land surface, vegetation, and shape of a coastal bluff reveals evidence of instability. Starting at the top of a bluff, an irregular or arcuate edge can indicate past landslides or areas of increased coastal erosion (Figure 3). When a weak point on a bluff fails, the slide moves inward into the slope face forming a curve around the original point of failure. Tension cracks may form near a weak zone where the soil surface is moving downslope (Figure 4). These cracks appear as splits in the ground where the soil and vegetation have moved apart. Cracks may be visible along the top edge of the bluff or on the bluff face itself. On the slope of a bluff, a hummocky land surface or terraces indicate past slumping or landslides (Figure 5). Unvegetated slump scars or slopes are obvious evidence of rapid soil movement. A bowl-shaped slope often shows the location of a former landslide, with the center of the bowl as the area of greatest failure. Distorted vegetation provides evidence of soil creep or former landslides. Tree trunks curved near their base are evidence of downslope movement (Figure 6). Trees tilted at different angles are evidence of former slides or undercutting by erosion. At the base of a bluff, toppled trees and bare roots are evidence of erosion that steepens the bluff (Figure 7). Undercutting and steepening of the bluff may destabilize the slope and lead to increased erosion and possibly a landslide. Lobes or terraces of sediment in the intertidal zone are often remnants of old landslides. Although the evidence of earth movement listed above cannot predict a landslide, it is used to recognize unstable shorelines. This landform evidence is related to factors listed below that influence landslide risk.

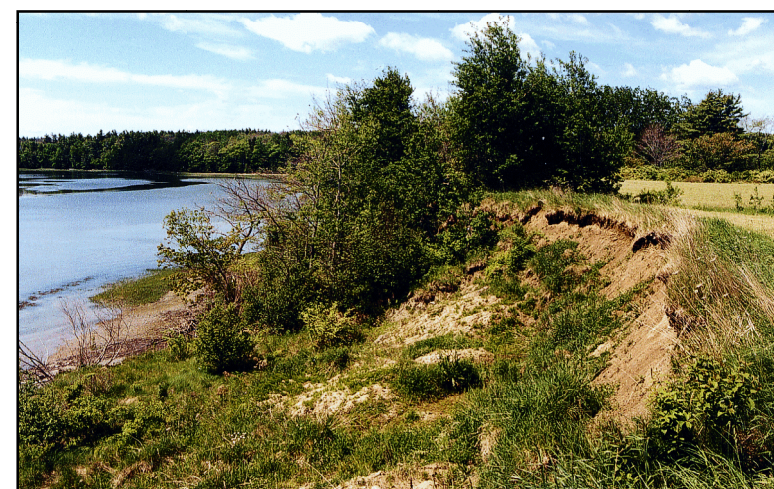
Figure 5. Terraces or a hummocky land surface on the slope of a bluff can indicate a former landslide. Terraces can be the surface of downwashed blocks which moved during a slide. Vegetation on the surface of these blocks may be tilted in various directions. The irregular land surface may also occur in a bowl-shaped depression below an arcuate top edge of the bluff, additional evidence of a former landslide.

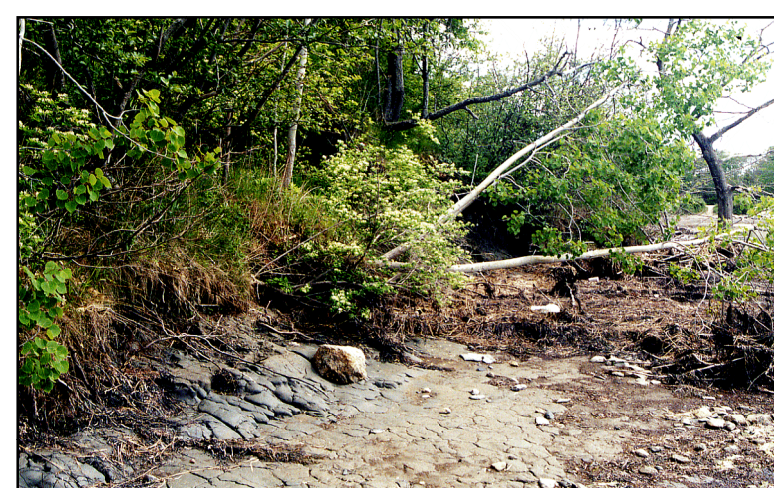
Figure 7. Wave erosion at the base of a bluff removes slope sediment and steepens the bluff. Erosion has undercut the trees in the photo above and caused them to tilt toward the ocean. This steepening reduces the stability of the bluff, and a landslide may result. Ongoing sea-level rise along the Maine coast will cause wave erosion at the base of coastal bluffs and continue to make some coastal bluffs at risk of experiencing a landslide.
