Coastal Bluffs

Classification and Mapping of Maine's Coastal Bluffs

Phippsburg Quadrangle, Maine

Open-File No. 02-204

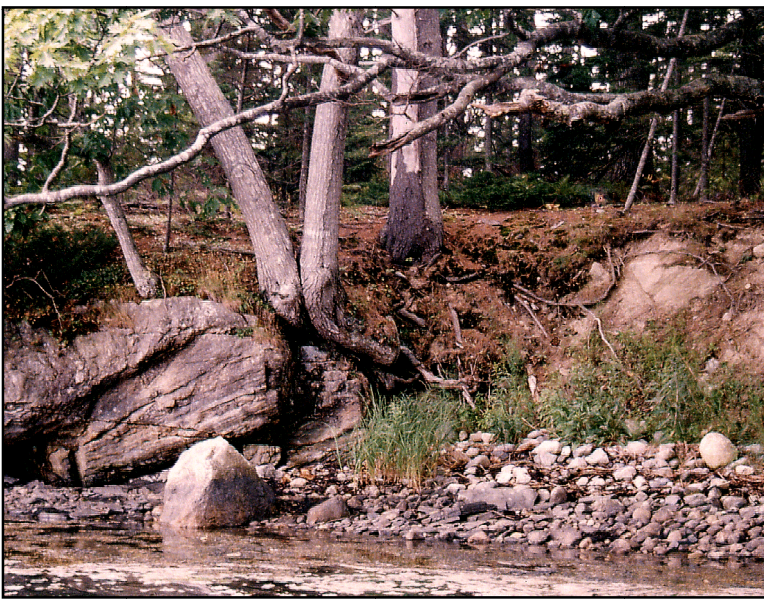
Map Resolution

Since these are regional maps, some shores mapped as stable may contain small areas that are unstable. A bluff, too small to appear on the map, is shown in the photo. This bluff exhibits the characteristics of an unstable bluff: curved tree trunks, exposed roots, and bare ground on a steep slope. It is an area to be concerned about on a local scale. However, this degree of detail is not shown on the map above.

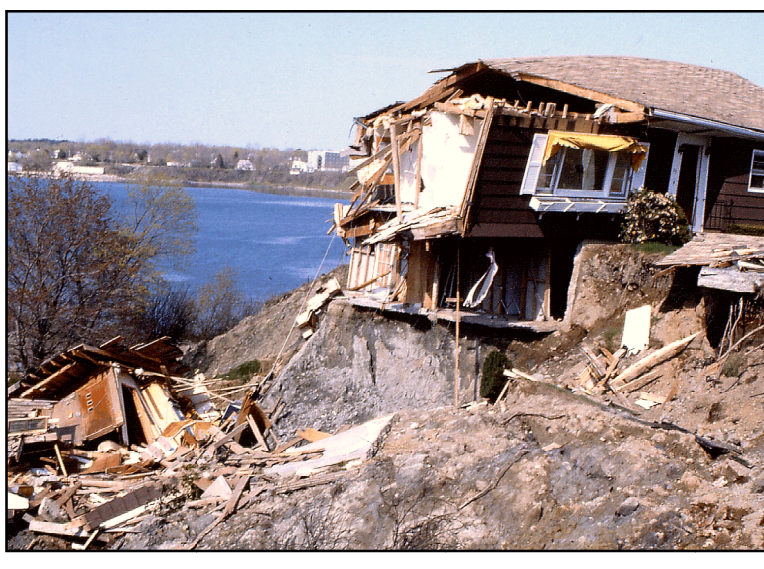
A 1996 landslide in Rockland Harbor (photo below) occurred in an area where the bluff face is classified as unstable. In addition, the bluff had all the characteristics (a-d) listed above. This fact is emphasized by the map above does not indicate sites with a potential for catastrophic landslides. Additional factors need to be considered beyond the appearance of the bluff face and type of shoreline below the bluff. Maps of topography, surficial sediments, and Coastal Landslide Hazards are available from the Maine Geological Survey to help assess the landslide potential in an area.

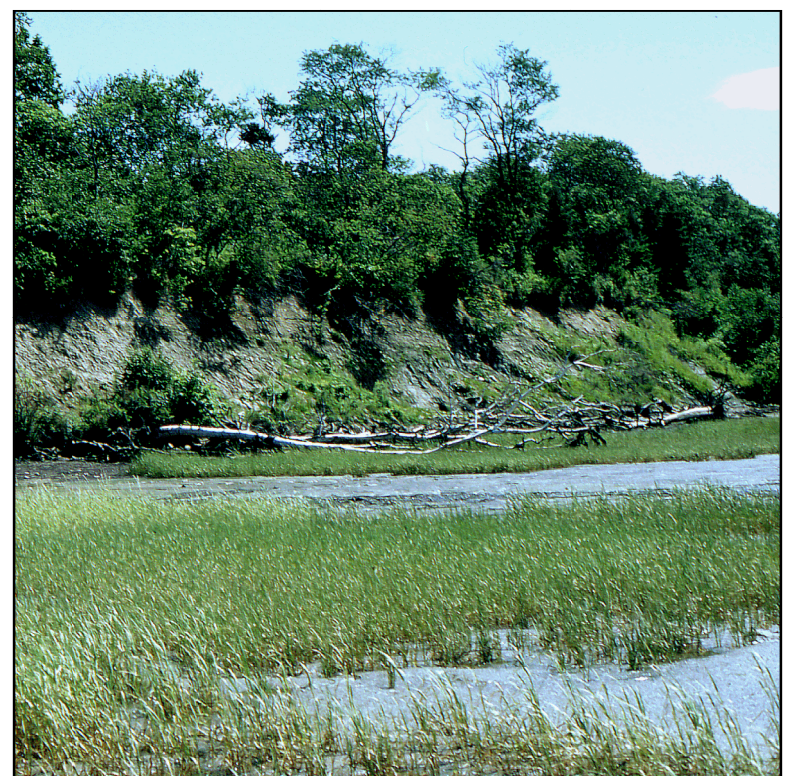
Highly unstable bluff with an unvegetated bluff face and a salt marsh shoreline. Sediments on the bluff face are exposed and fallen tree trunks lie at the base of the bluff. A salt marsh has recently formed on the tidal flat, partly on the top of an old landslide-deposit.

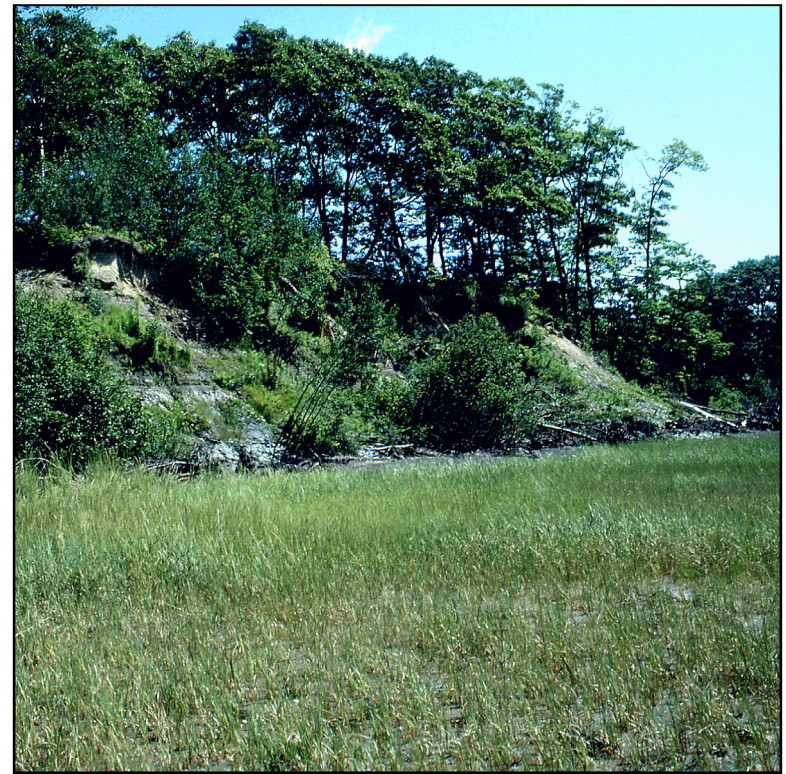
Unstable bluff with a partially vegetated bluff face and a salt marsh shoreline. This bluff, protected by a salt marsh, remains unstable. There are small bushes on the bluff as well as small non-vegetated areas that indicate continuing bluff retreat.

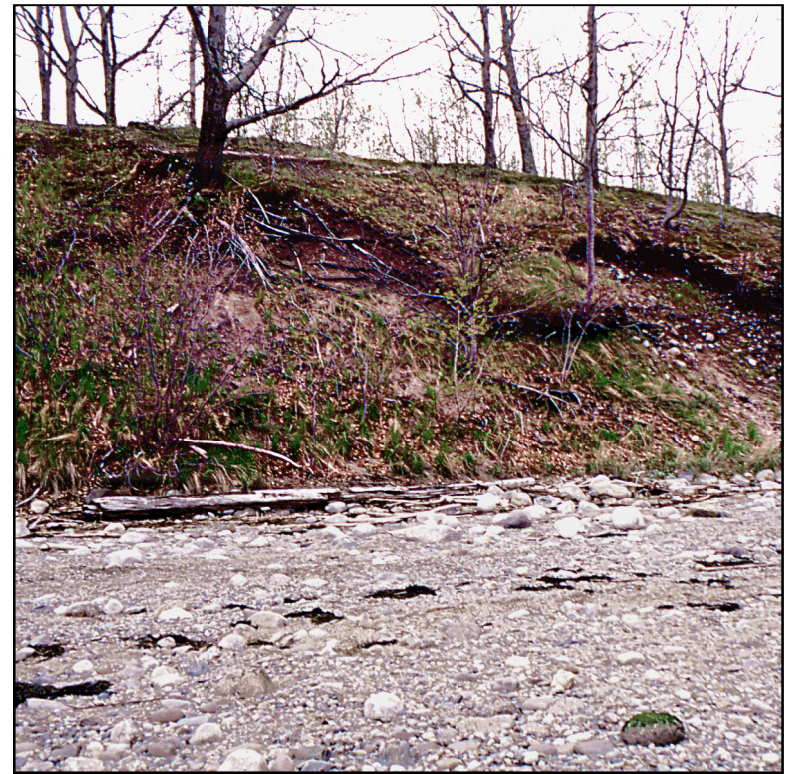
Unstable bluff with a partially vegetated bluff face and a beach/gravel flat shoreline. Slump scars on the bluff face expose sand, gravel, and roots. Fine sediments are removed by waves and currents, leaving gravel to form a beach at the base of the bluff.

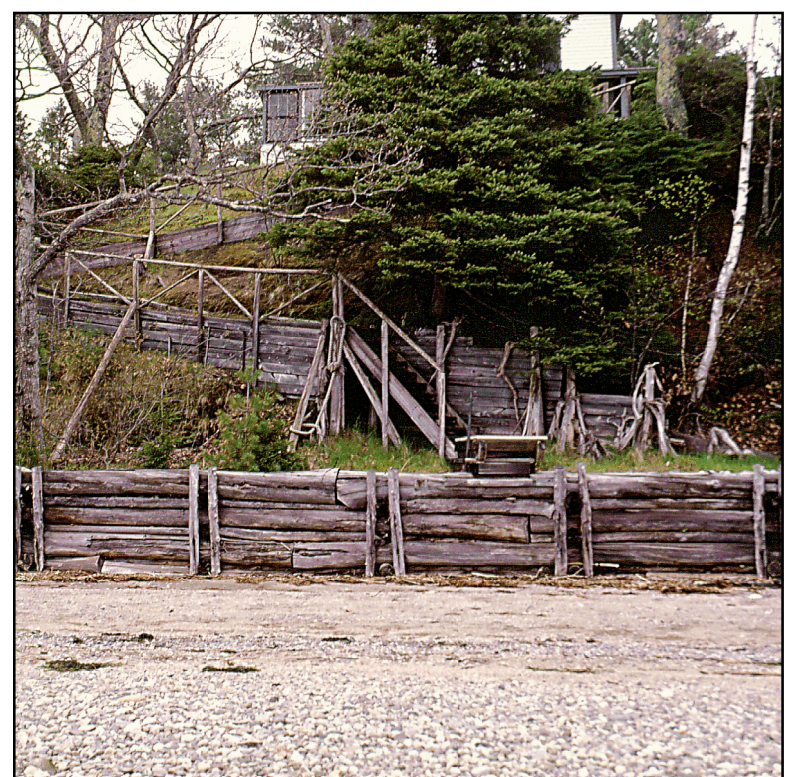
Stable bluff with a vegetated bluff face and an armored shoreline. The bluff face is fully vegetated and supports a mature stand of trees with vertical trunks. The presence of a wooden bulkhead suggests that erosion has occurred in the past.

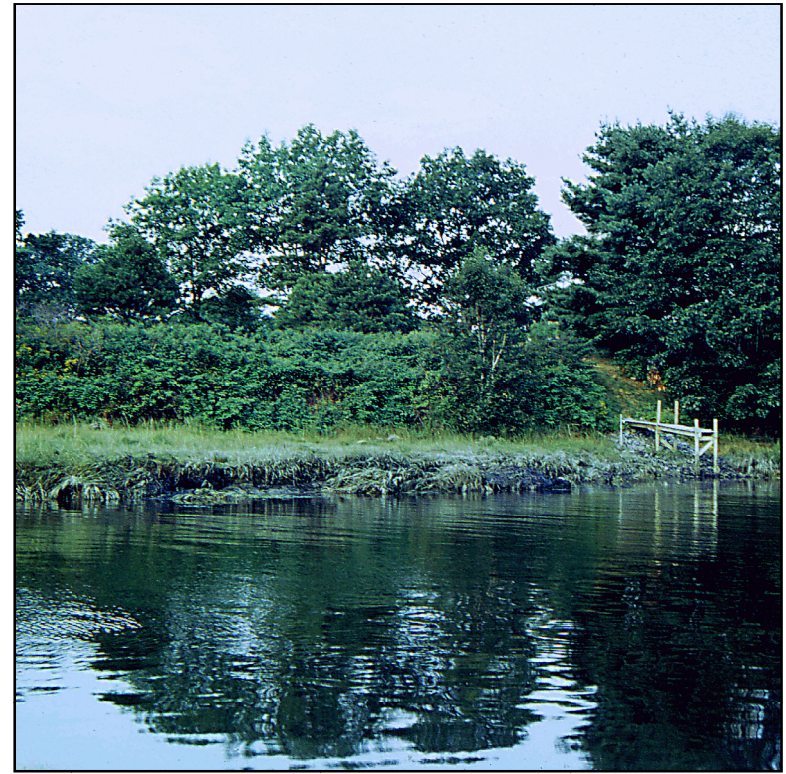
Stable bluff with a vegetated bluff face and a salt marsh shoreline. A low bluff face is covered by shrubs landward of a salt marsh terrace. In this location the mature marsh protects the base of the bluff from rapid erosion and slows bluff recession or retreat.

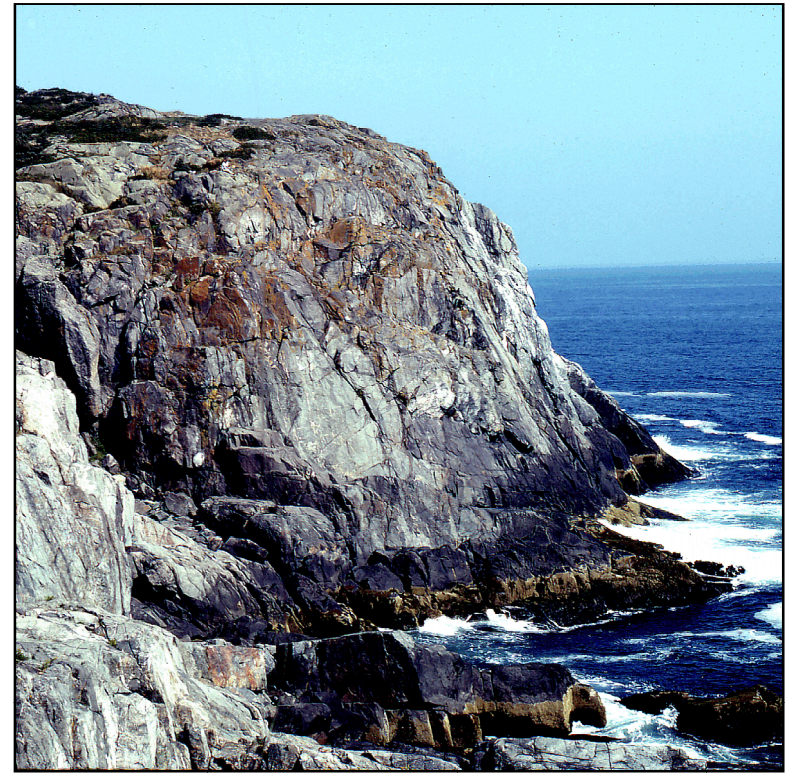
No bluff with a ledge shoreline. A steep slope on the bedrock surface is not a bluff. On this map, bluffs must be made of sedimentary material, generally with 3 feet or more of relief. This shoreline type is very slow to change.
