# Coastal Bluffs

## Classification and Mapping of Maine's Coastal Bluffs

# Camden Quadrangle, Maine

Open-File No. 02-181  
2002

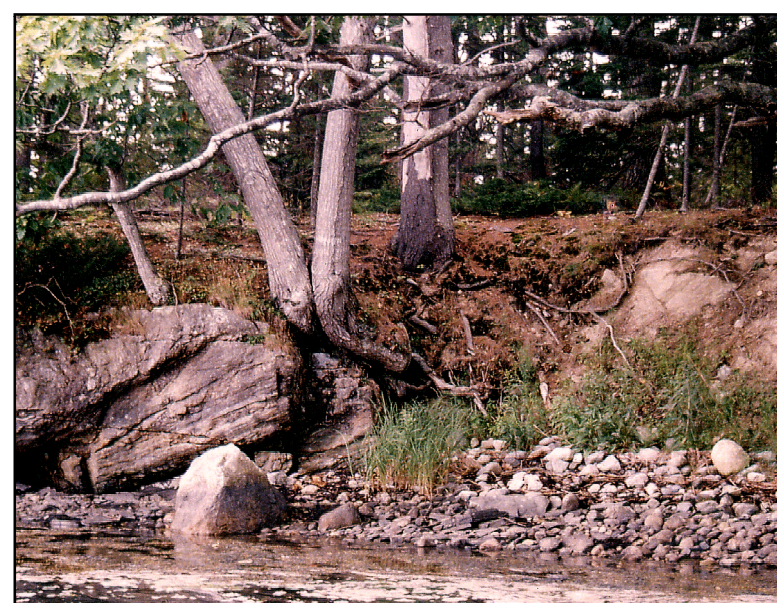
Since these are regional maps, some shore mapped as stable may contain small areas that are unstable. A bluff, too small to appear on the map, is shown in the photo. This bluff exhibits the characteristics of an unstable bluff: curved tree trunks, exposed roots, and bare ground on a steep slope. It is an area to be concerned about on a local scale. However, this degree of detail is not shown on the map above.

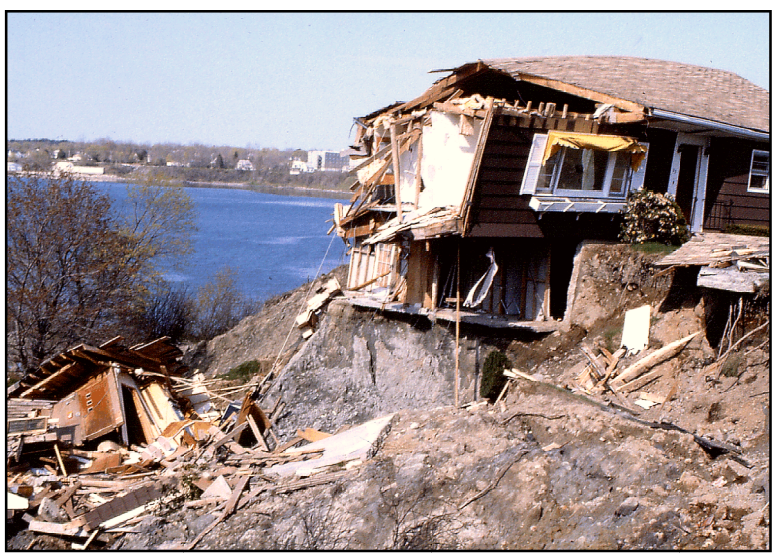
A 1996 landslide in Rockland Harbor (photo below) occurred in an area where the bluff face is classified as unstable. In addition, the bluff had all the characteristics (a-d) listed above. This fact emphasizes that the map above does not indicate sites with a potential for catastrophic landslides. Additional factors need to be considered beyond the appearance of the bluff face and type of shoreline below the bluff. Maps of topography, surficial sediments, and Coastal Landslide Hazards are available from the Maine Geological Survey to help assess the landslide potential in an area.

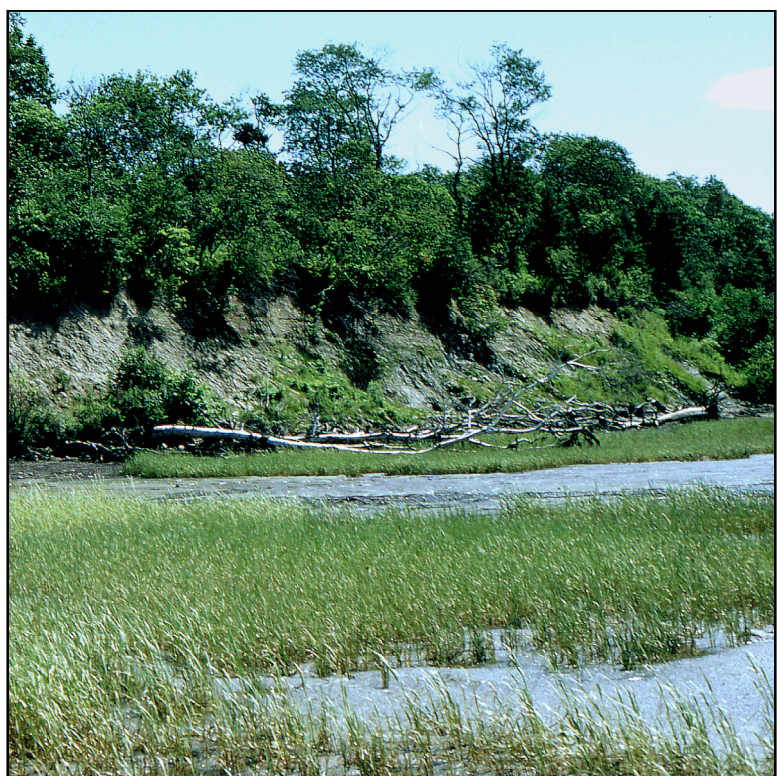
**Highly unstable bluff** with an unvegetated bluff face and a salt marsh shoreline. Sediments on the bluff face are exposed and fallen tree trunks lie at the base of the bluff. A salt marsh has recently formed on the tidal flat, partly on the top of an old landslide deposit.

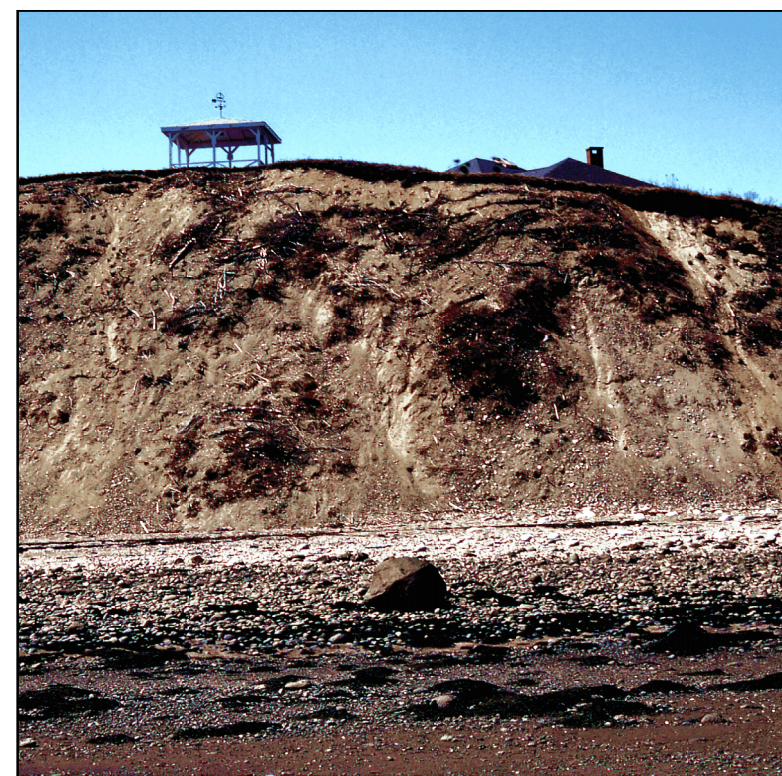
**Highly unstable bluff** with an unvegetated bluff face and a beach/gravel flat shoreline. The bluff face is too unstable to support vegetation. This bluff, a glacial esker, is eroded by waves to create a mixed sand and gravel beach in front of the bluff.

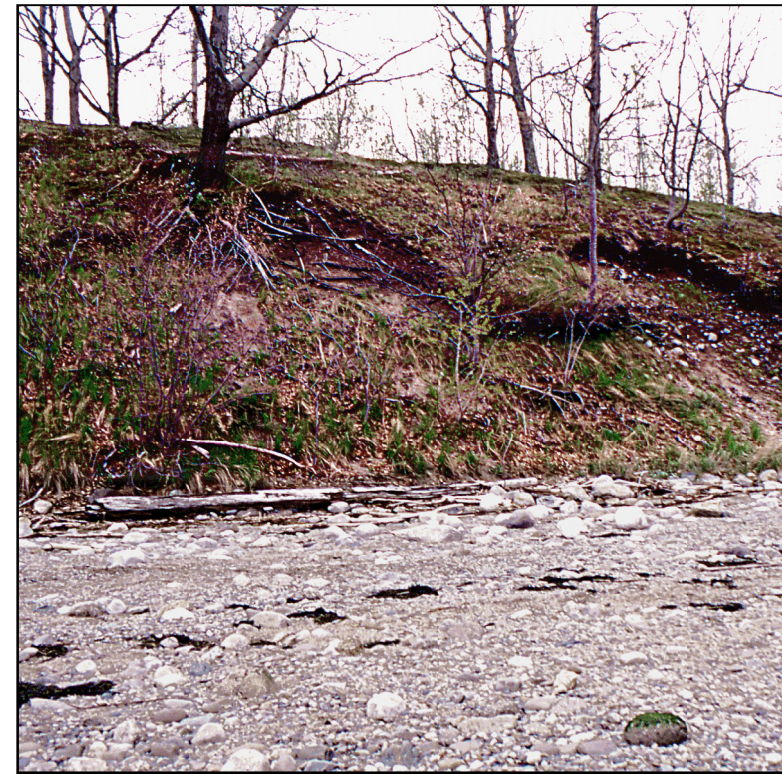
**Unstable bluff** with a partially vegetated bluff face and a beach/gravel flat shoreline. Slump scars on the bluff face expose sand, gravel, and roots. Fine sediments are removed by waves and currents, leaving gravel to form a beach at the base of the bluff.

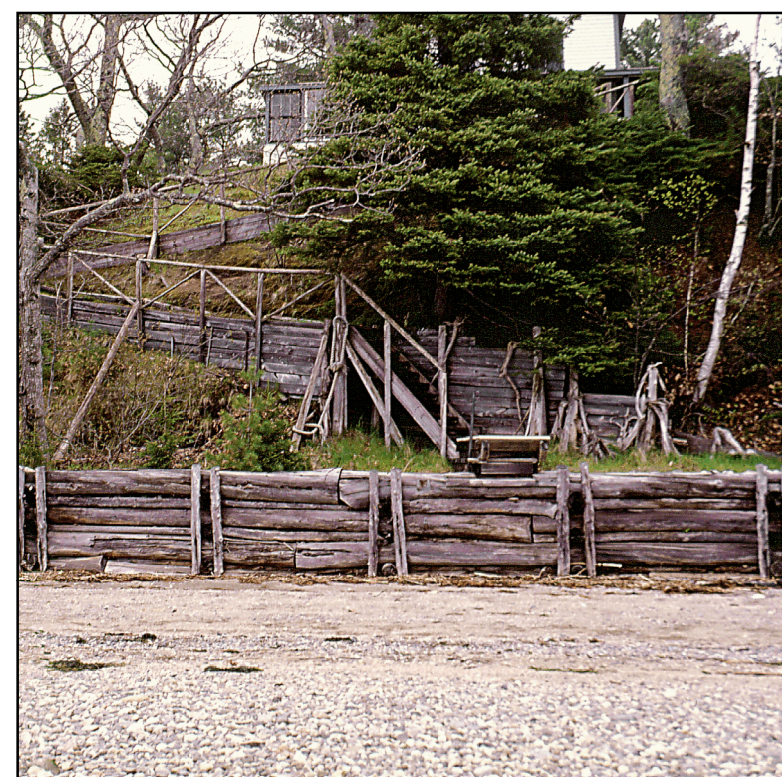
**Stable bluff** with a vegetated bluff face and an armored shoreline. The bluff face is fully vegetated and supports a mature stand of trees with vertical trunks. The presence of a wooden bulkhead suggests that erosion has occurred in the past.

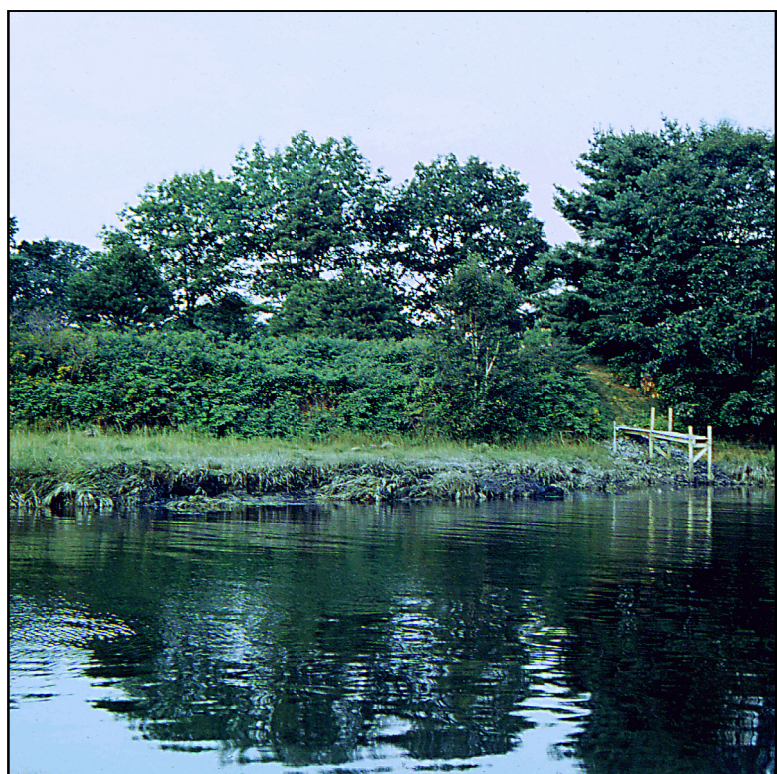
**Stable bluff** with a vegetated bluff face and a salt marsh shoreline. A low bluff face is covered by shrubs landward of a salt marsh terrace. In this location the nature marsh protects the base of the bluff from rapid erosion and slows bluff recession or retreat.
