Coastal Bluffs

Classification and Mapping of Maine's Coastal Bluffs

Small Point Quadrangle, Maine

Open-File No. 02-213

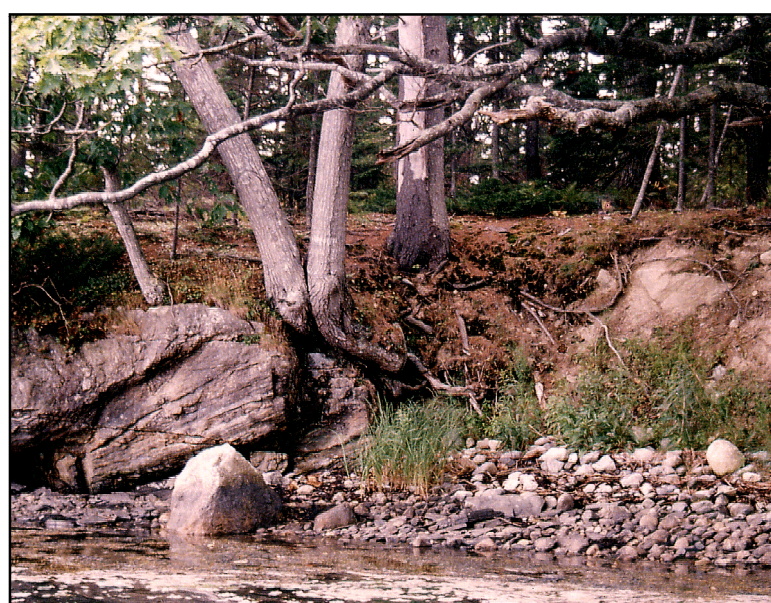
Map Resolution

Since these are regional maps, some areas may contain small areas that are unstable. A bluff, too small to appear on the map, is shown in the photo. This bluff exhibits the characteristics of an unstable bluff: curved tree trunks, exposed roots, and bare ground on a steep slope. It is an area to be concerned about on a local scale. However, this degree of detail is not shown on the map above.

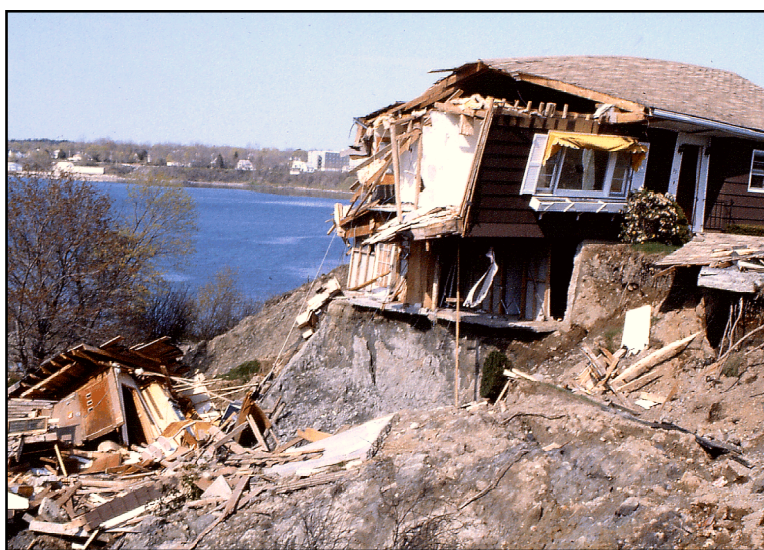
A 1996 landslide in Rockland Harbor (photo below) occurred in an area where the bluff face is classified as unstable. In addition, the bluff had all the characteristics (a-d) listed above. This fact
