Coastal Bluffs

Classification and Mapping of Maine's Coastal Bluffs

Hampden Quadrangle, Maine

Open-File No. 02-190
2002

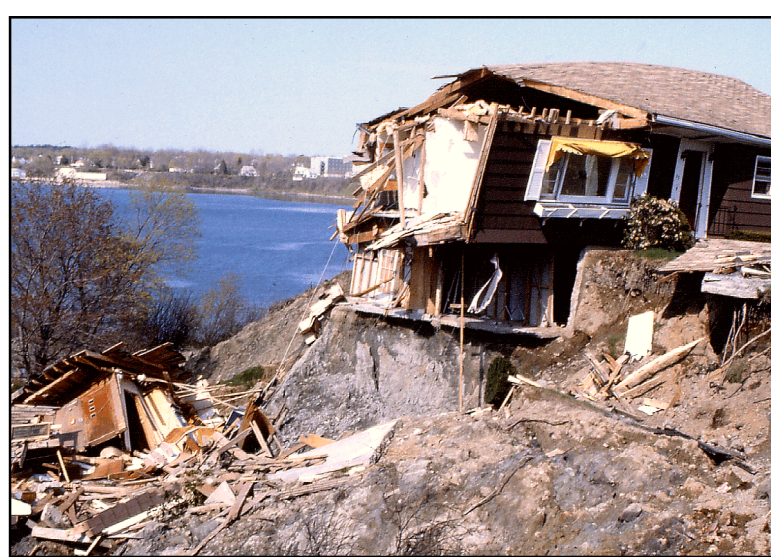
A 1996 landslide in Rockland Harbor (photo below) occurred in an area where the bluff face is classified as unstable. In addition, the bluff had all the characteristics (a-d) listed above. This fact emphasizes that the map above does not indicate sites with a potential for catastrophic landslides.

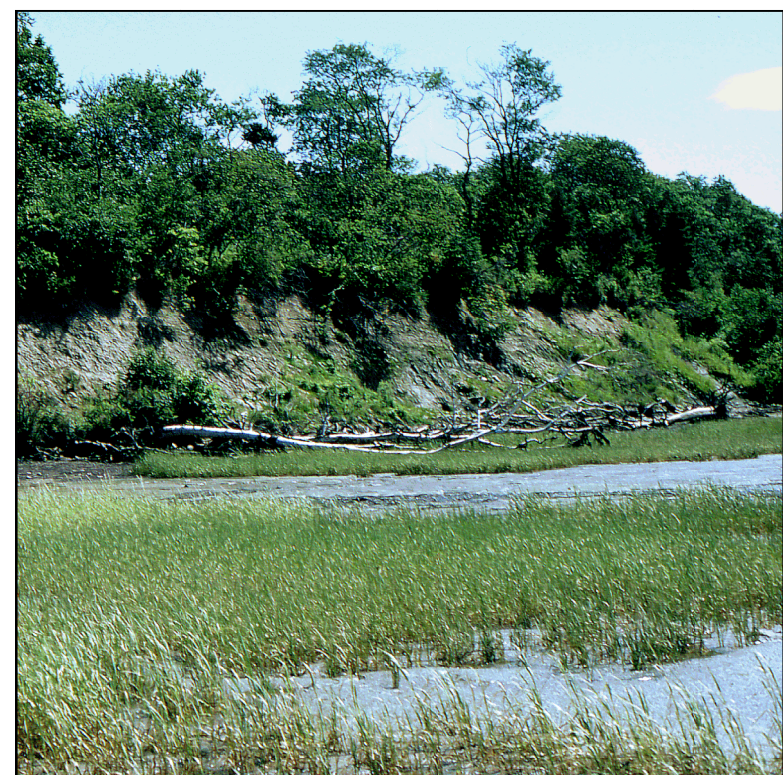
Highly unstable bluff with an unvegetated bluff face and a salt marsh shoreline. Sediments on the bluff face are exposed and fallen tree trunks lie at the base of the bluff. A salt marsh has recently formed on the tidal flat, partly on the top of an old landslide deposit.

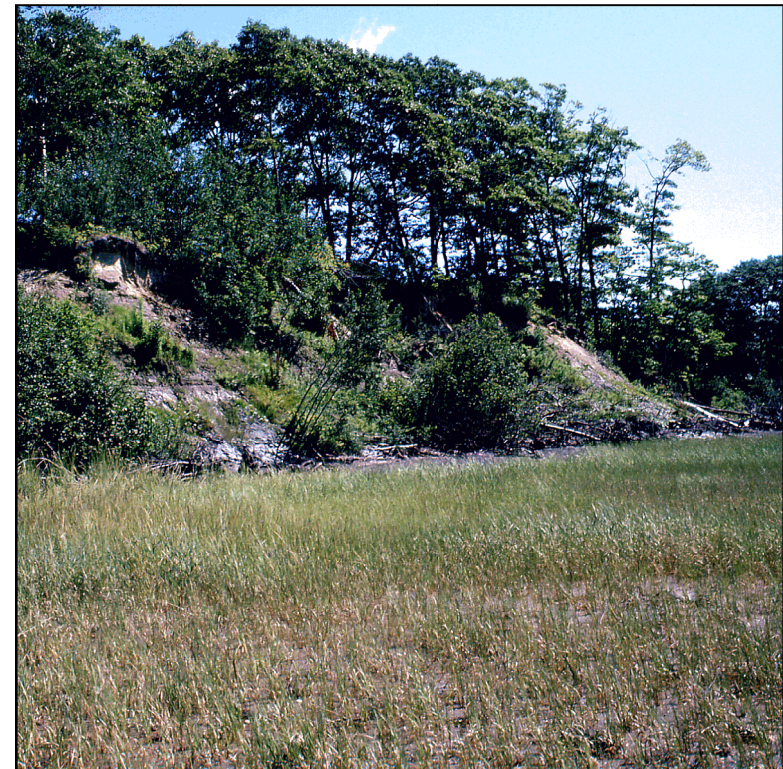
Unstable bluff with a partially vegetated bluff face and a salt marsh shoreline. This bluff, protected by a salt marsh, remains unstable. There are small bushes on the bluff as well as small non-vegetated areas that indicate continuing bluff retreat.

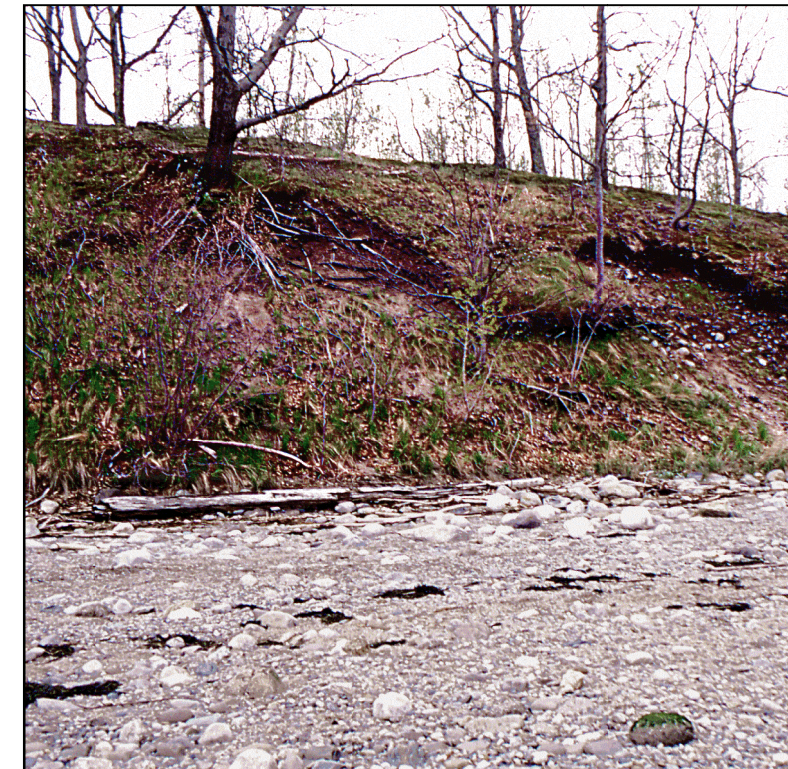
Unstable bluff with a partially vegetated bluff face and a beach/gravel flat shoreline. Slump scars on the bluff face expose sand, gravel, and roots. Fine sediments are removed by waves and currents, leaving gravel to form a beach at the base of the bluff.

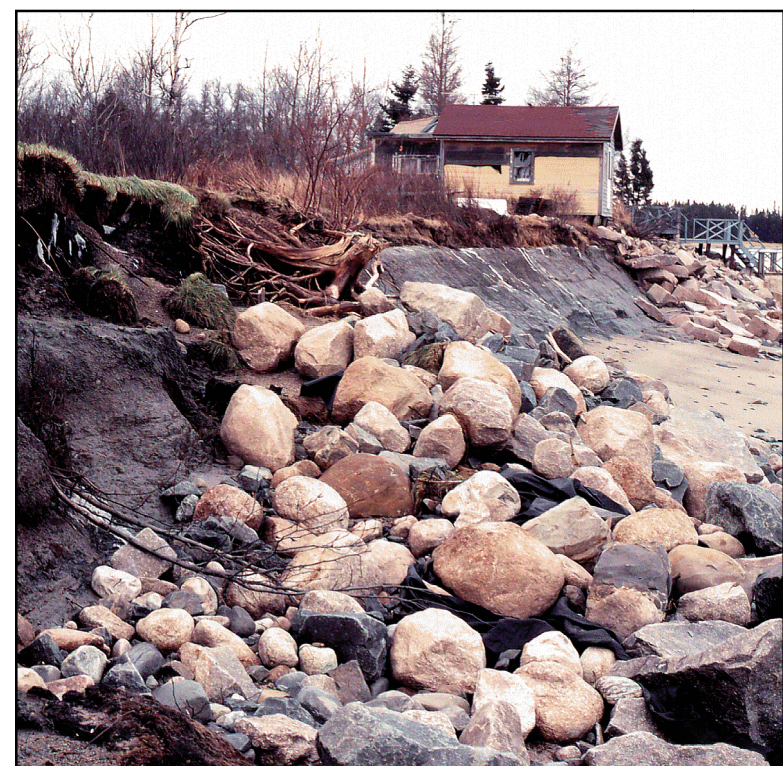
Highly unstable bluff with an unvegetated bluff face and an armored shoreline. This armored bluff is eroding despite an effort to shore it up with riprap, or loosely piled stone blocks. Maintenance at this site could improve bluff stability.

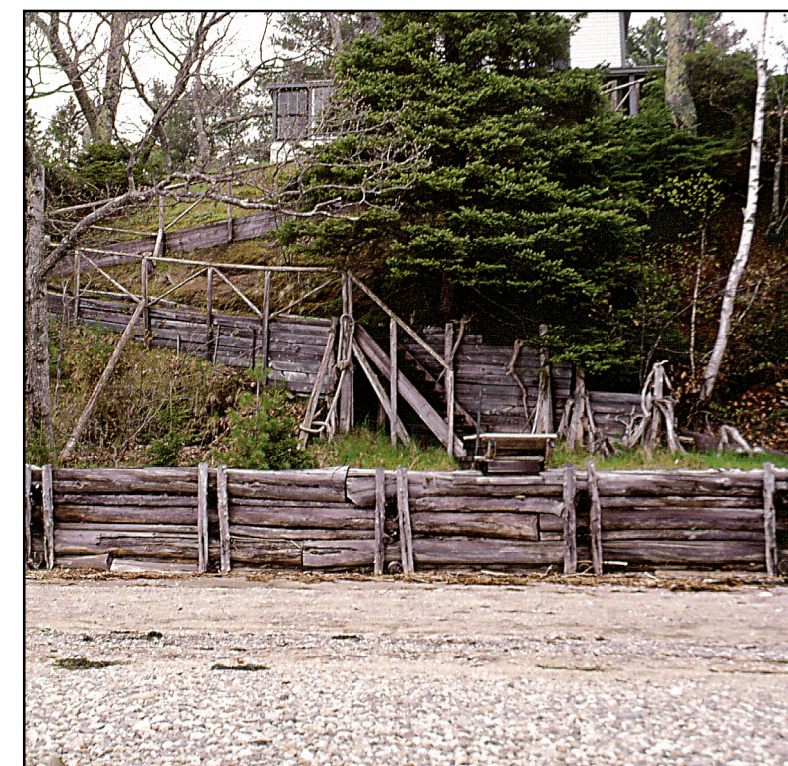
Stable bluff with a vegetated bluff face and an armored shoreline. The bluff face is fully vegetated and supports a mature stand of trees with vertical trunks. The presence of a wooden bulkhead suggests that erosion has occurred in the past.

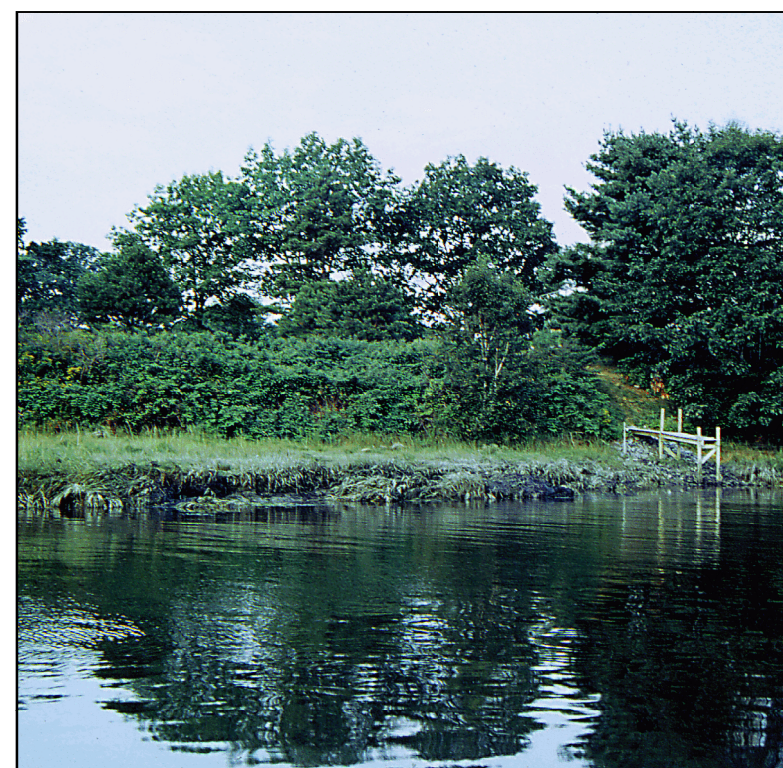
Stable bluff with a vegetated bluff face and a salt marsh shoreline. A low bluff face is covered by shrubs landward of a salt marsh terrace. In this location the mature marsh protects the base of the bluff from rapid erosion and slows bluff recession or retreat.
